Case Study | Route-based Vibration Analysis

Machine Overview

- Cardboard
 - Max Speed 780 MPM
- Running Speed: 165 RPM
- Measurement periodicity: **3 weekly (offline) measurements**
- **Problem:** Bearing damages on drying cylinders

Cylinder 26 - Measurement of the Drive Side Bearing

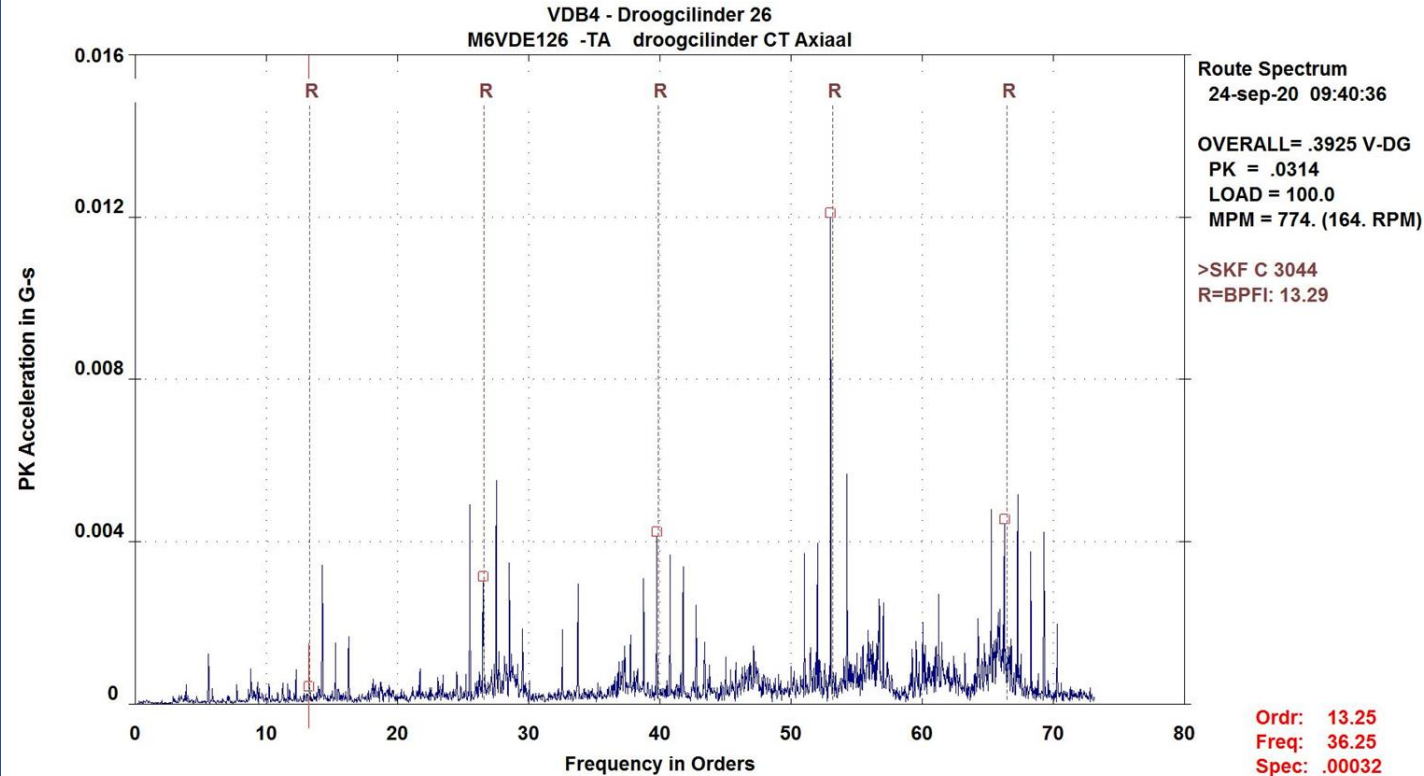
- During the routine vibration measurements at PM6, an **increase of the vibration levels** is noted on the drive side of the drying cylinder 26.
- **Asynchronous frequencies** at 13,2 x order became visible with sidebands on 1x order in the spectra.
- However, 13,2x order doesn't match with any fault frequencies of 23,044 CCK type bearing (with 25 rolling elements).

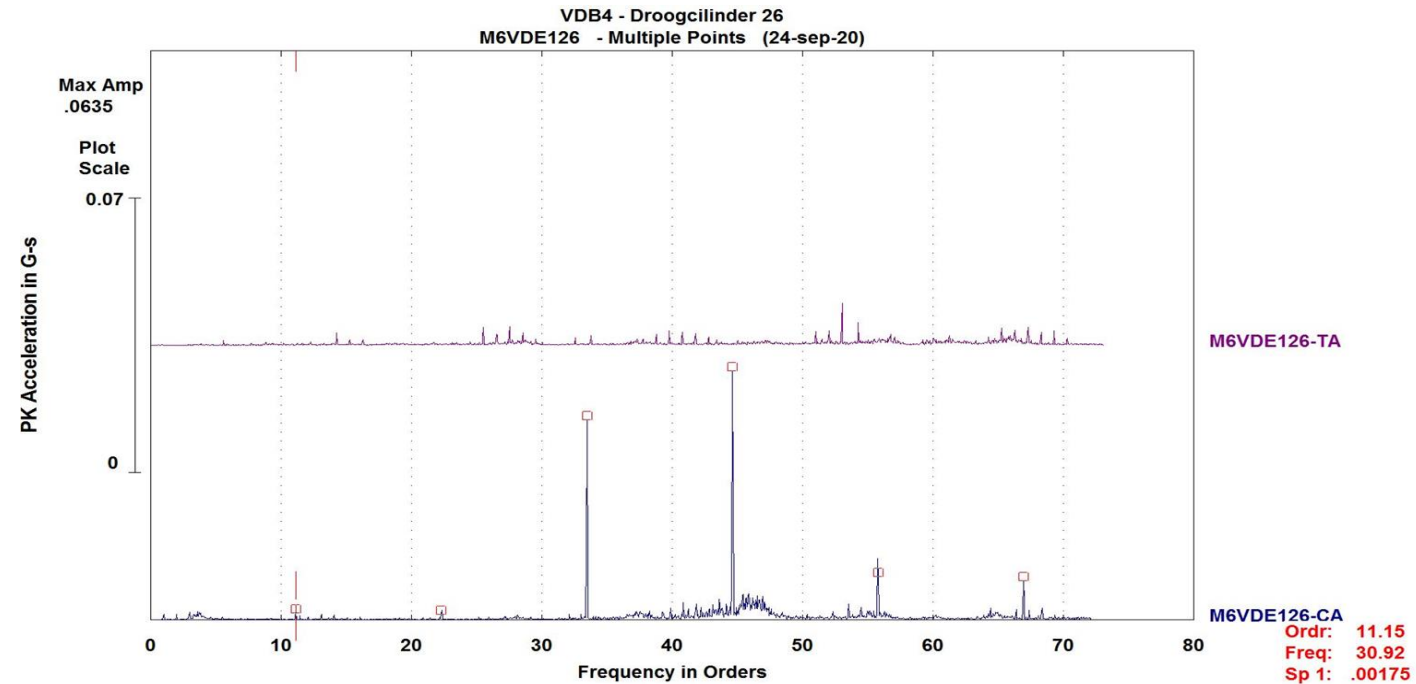
Comparison of Both Sides

- When the measurements of both bearings are compared with each other, the amplitude level of the front side bearing was quite high.
- Keep in mind that the front side had a quite stable trend (i.e. no indication of a serious deterioration).

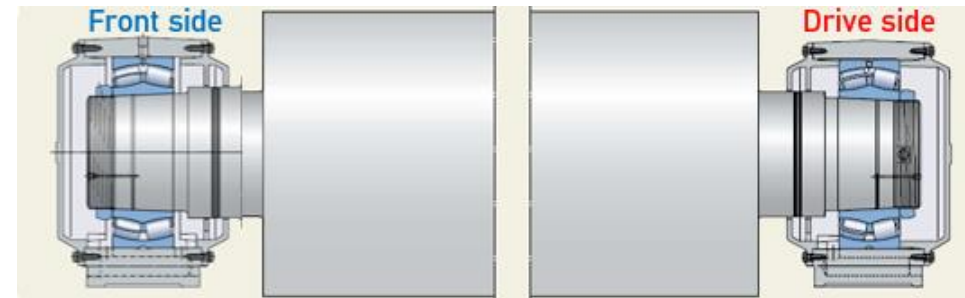
VIB: BPFO (moderate)
 NOISE: no damage

VIB: BPFI (mild)
 NOISE: damage

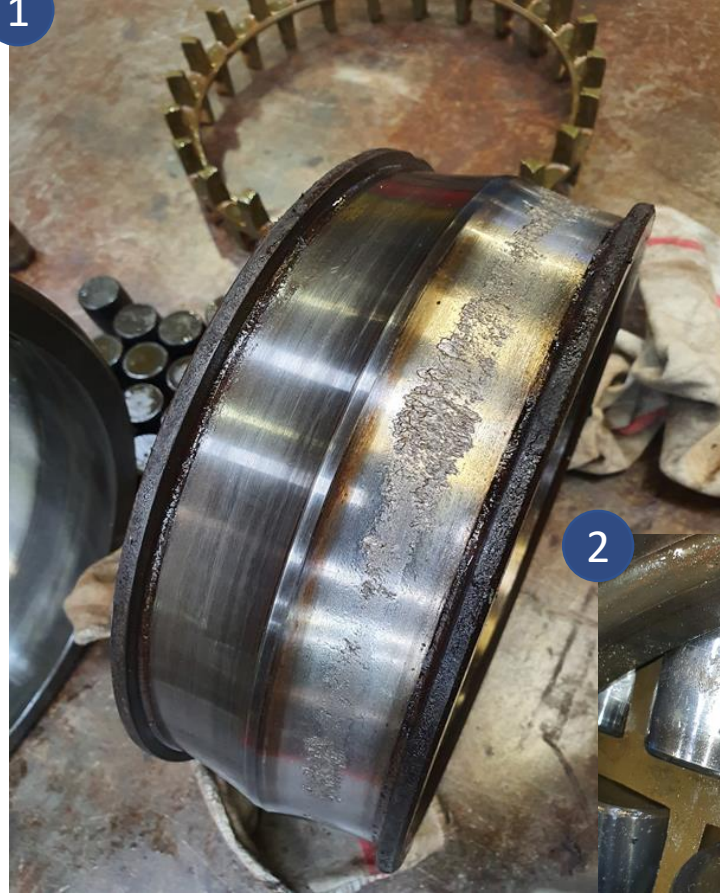
1

- The evolution of both bearing damages is monitored further. After a while, the amplitude levels of the drive side bearing increased.
- A bearing replacement is planned during the next planned shutdown to avoid an imminent failure.

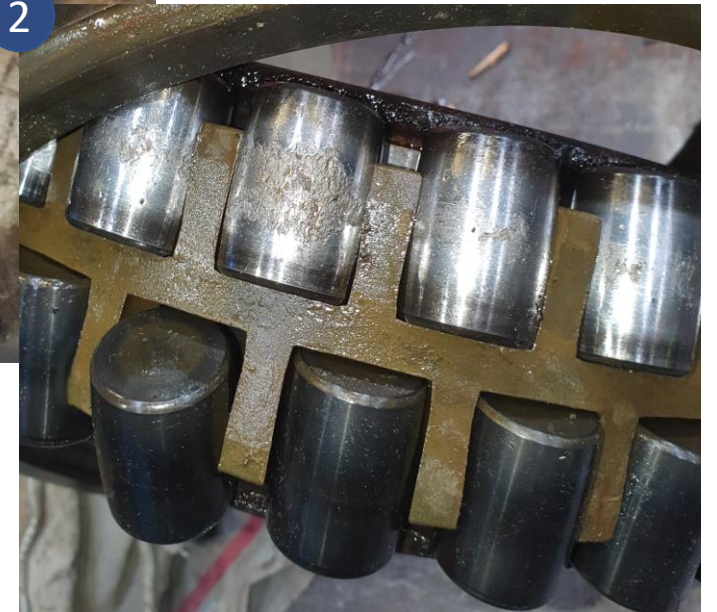
2

Signs of abrasive wear and spalling are clearly seen on the right rolling contact surface; as a result of bearing misalignment and/or excessive axial thrust.

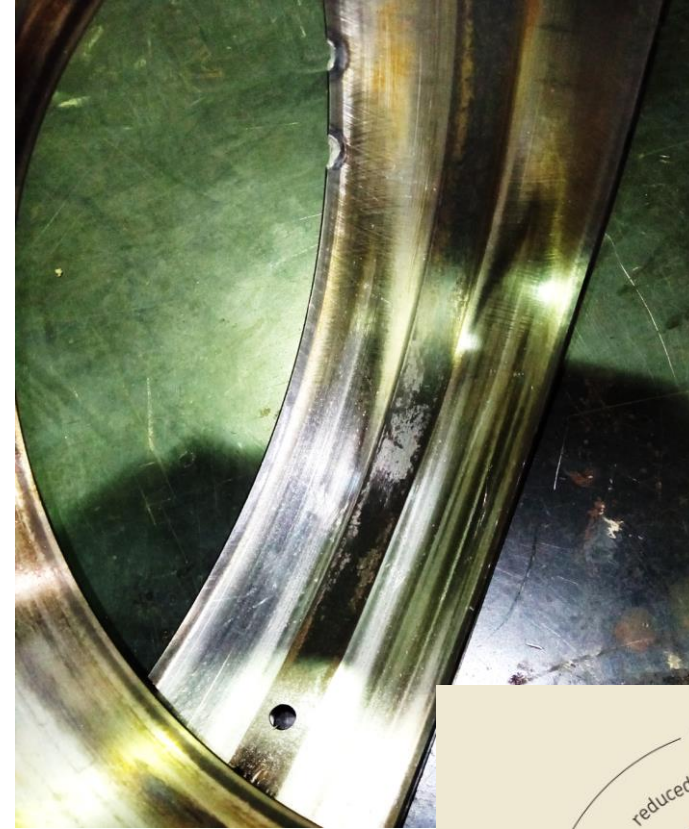
Later, the front side bearing is also replaced during the subsequent planned shutdown. **Signs of polishing wear** are clearly visible on the **rolling elements** and on the **outer raceway**.

The most usual explanation for mirror-like raceway surfaces in a rolling bearing is that the bearing has been **poorly lubricated**, which normally means a thin oil film. A thin oil film allows metal-to-metal contact that leads to wear and plastic deformation of asperities.

The **viscosity** of the oil is too low and there are a lot of very small abrasive contaminant particles in the oil. Then the bearing becomes subjected to continuous polishing wear. These microparticles are always present in a lubricant, but not every bearing with a thin oil film becomes polished. **Why does this happen?** It is presumed that there are additional factors influencing the start of the polishing wear process, e.g. a certain **combination of low speed, heavy load, and thin oil film**.

The best way to avoid this kind of abrasive polishing wear is to increase the oil film thickness and use oils with good **EP or AW properties**.

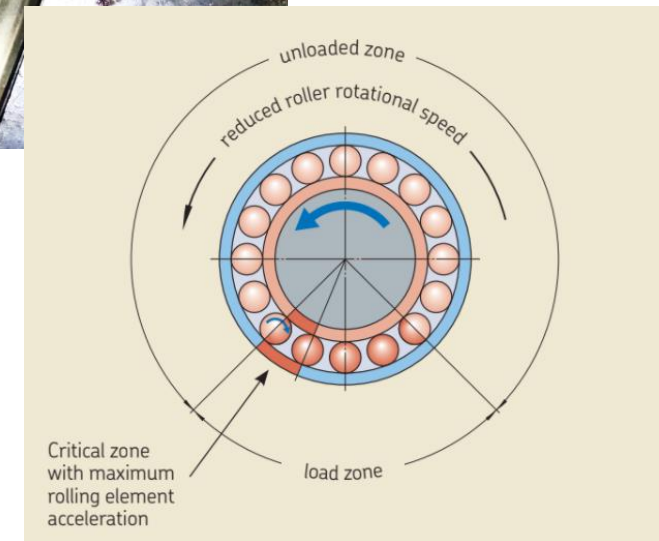
Shiny surfaces on the entrance of the load zone

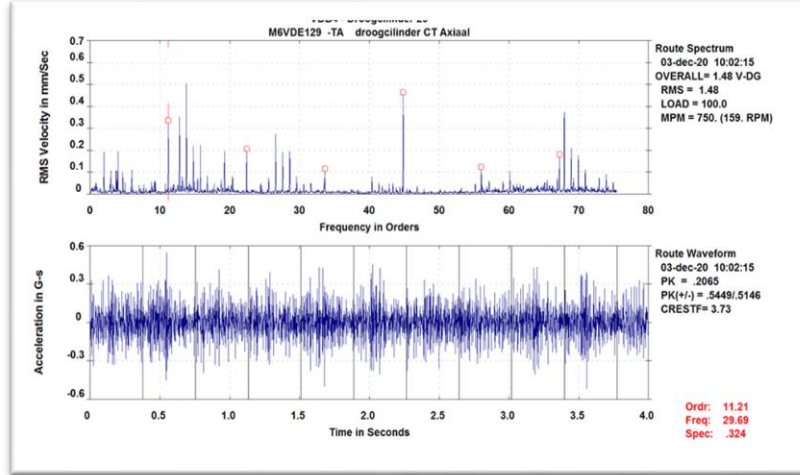
BPFO at 11,2x order

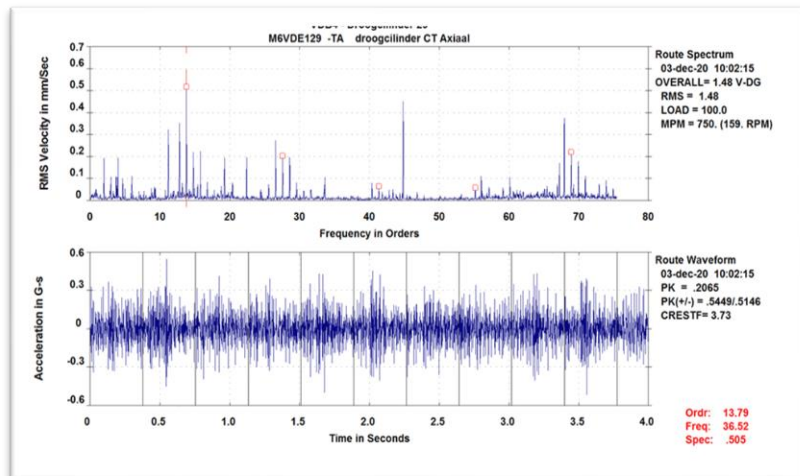
BPFI at 13,8x order

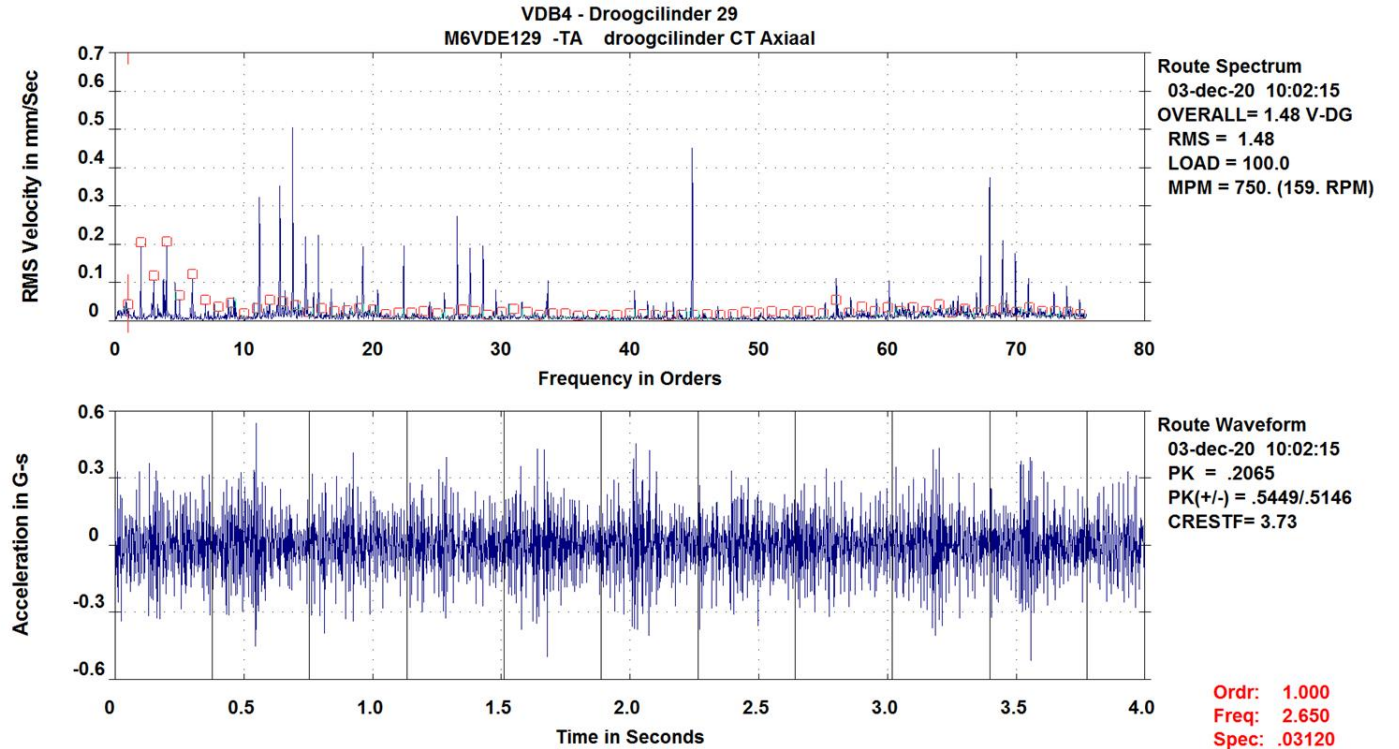
1x order and harmonics:

Likely some looseness or an indication of severe bearing damage (because bearing fault frequencies are also present)?

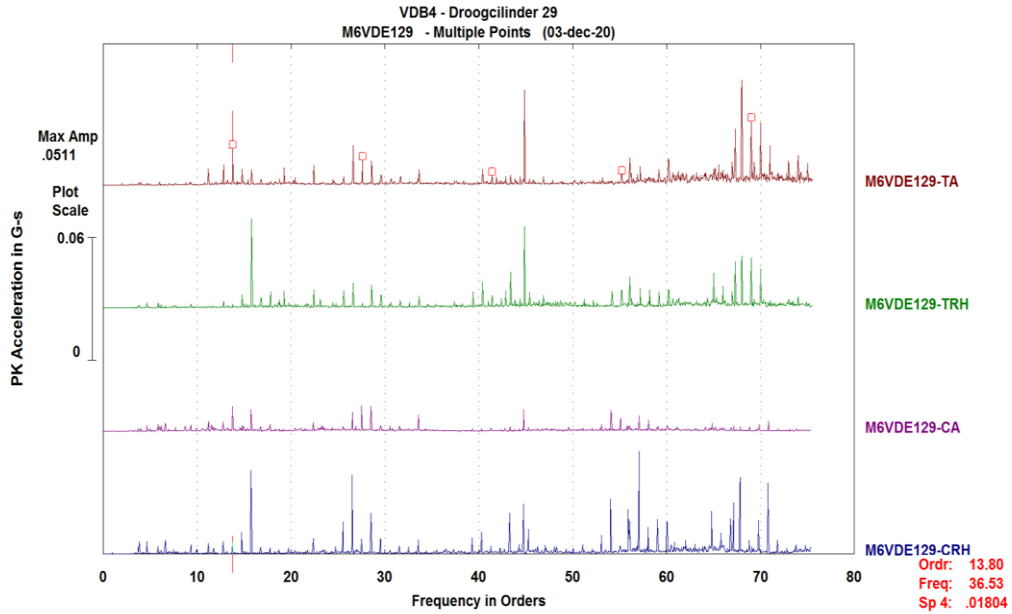
Drive side

Given more sidebands at 1x, BRFI (13,8x) on the front side?

Or given higher amplitude levels, BRF0 (11,2x) on the drive side?

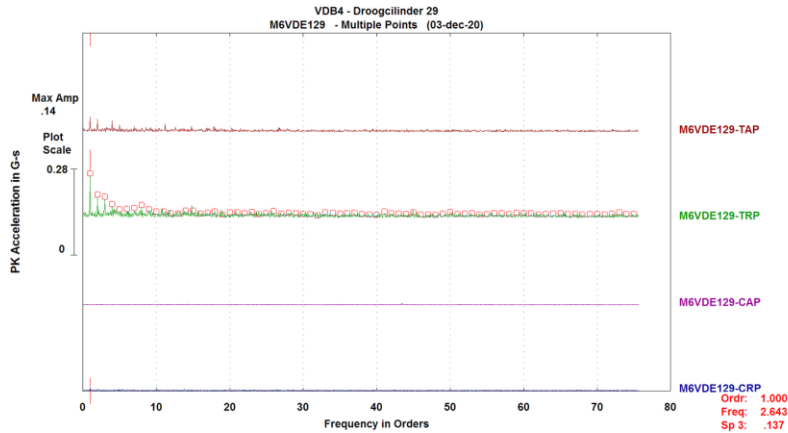
High-frequency impacts at 1x order can be a sign of inner ring cracking. Which means: *“Envelope measurements such as PeakVue, SPM HD, or Spike are used to detect stress waves due to impacting (metal-metal contact), friction, and fatigue cracking. Stress waves propagate in all directions and the velocity at which the waves propagate away from the damage location is proportional to the square root of frequency. So the amplitude will decrease and the duration of the event will increase as the measurement point is further removed from the initiation site.”*

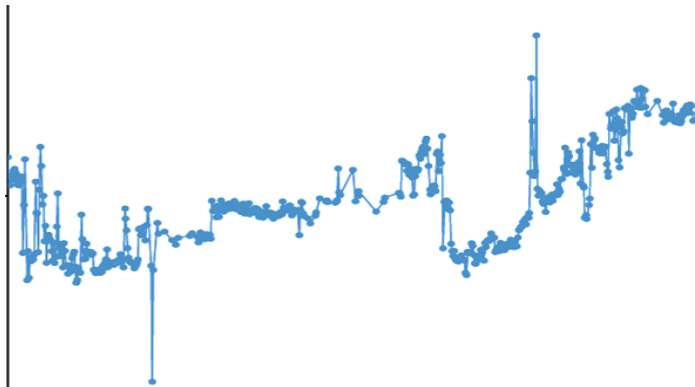
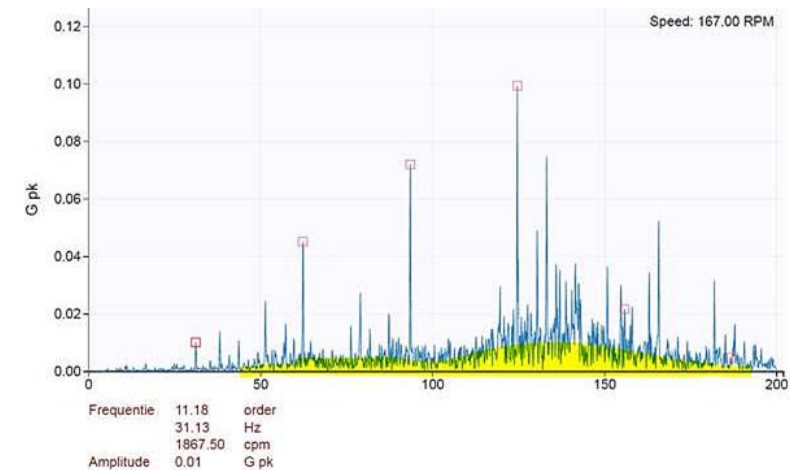
The gradual increase of the noise floor in the vibration spectrum is noted after a period of time which is a sign of deterioration on the rolling surfaces.

Note: The overall vibration level and the amplitude levels of the bearing fault frequencies showed no radical changes.

To closely follow up the vibration level and the spectral noise, a **hybrid monitoring method** is applied at this aged paper mill by using Wi-care 100 wireless sensors.

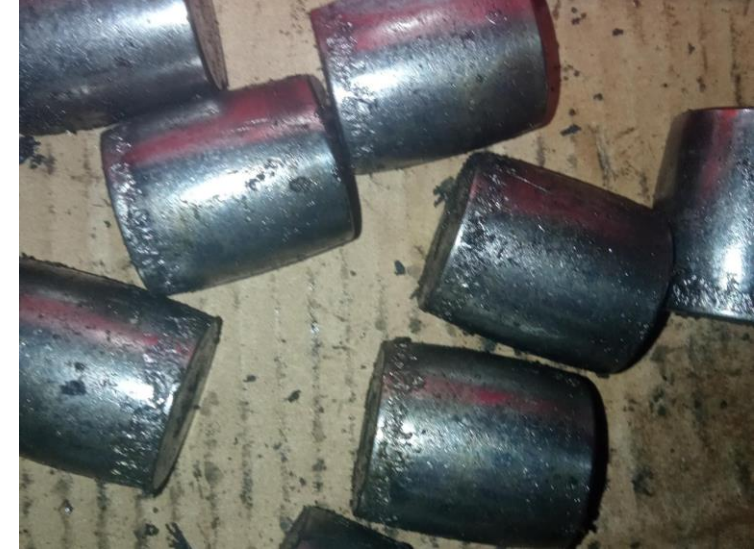
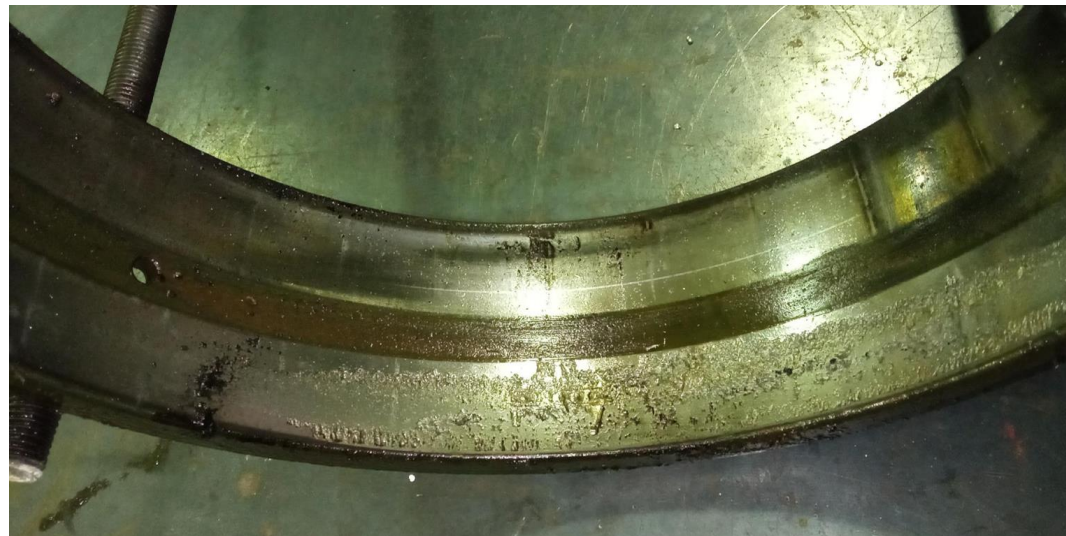
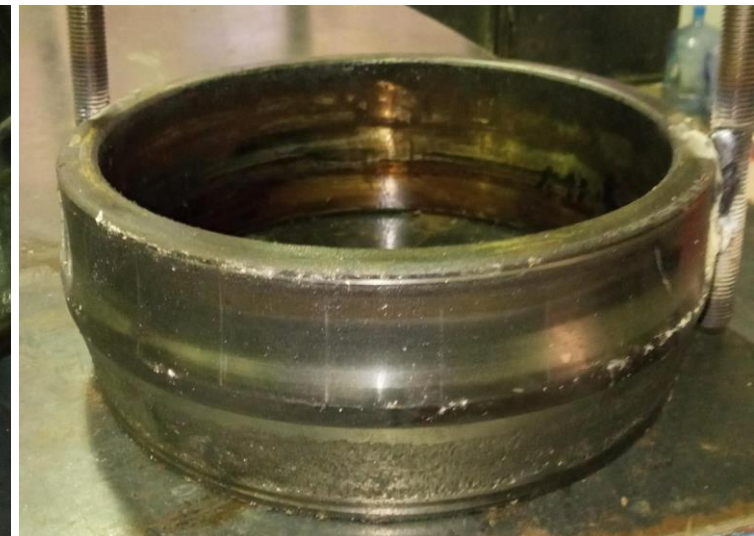
The rolling surface on one side was severely damaged due to excessive bearing misalignment probably due to a deformed housing or machine frame.

- Abrasive wear on one side due to high load and the bearing's internal misalignment: the front side locating bearing has probably not enough space for axial displacement.
- Fretting corrosion on the shaft and on the inner diameter. Keep in mind that 1x order with harmonics was visible in the spectra due to a probable loose fit on the shaft.

The drive side bearing is replaced during the planned shutdown. Fortunately, the inner ring was not cracked.
