Case Study | Wireless Monitoring System

Machine Overview

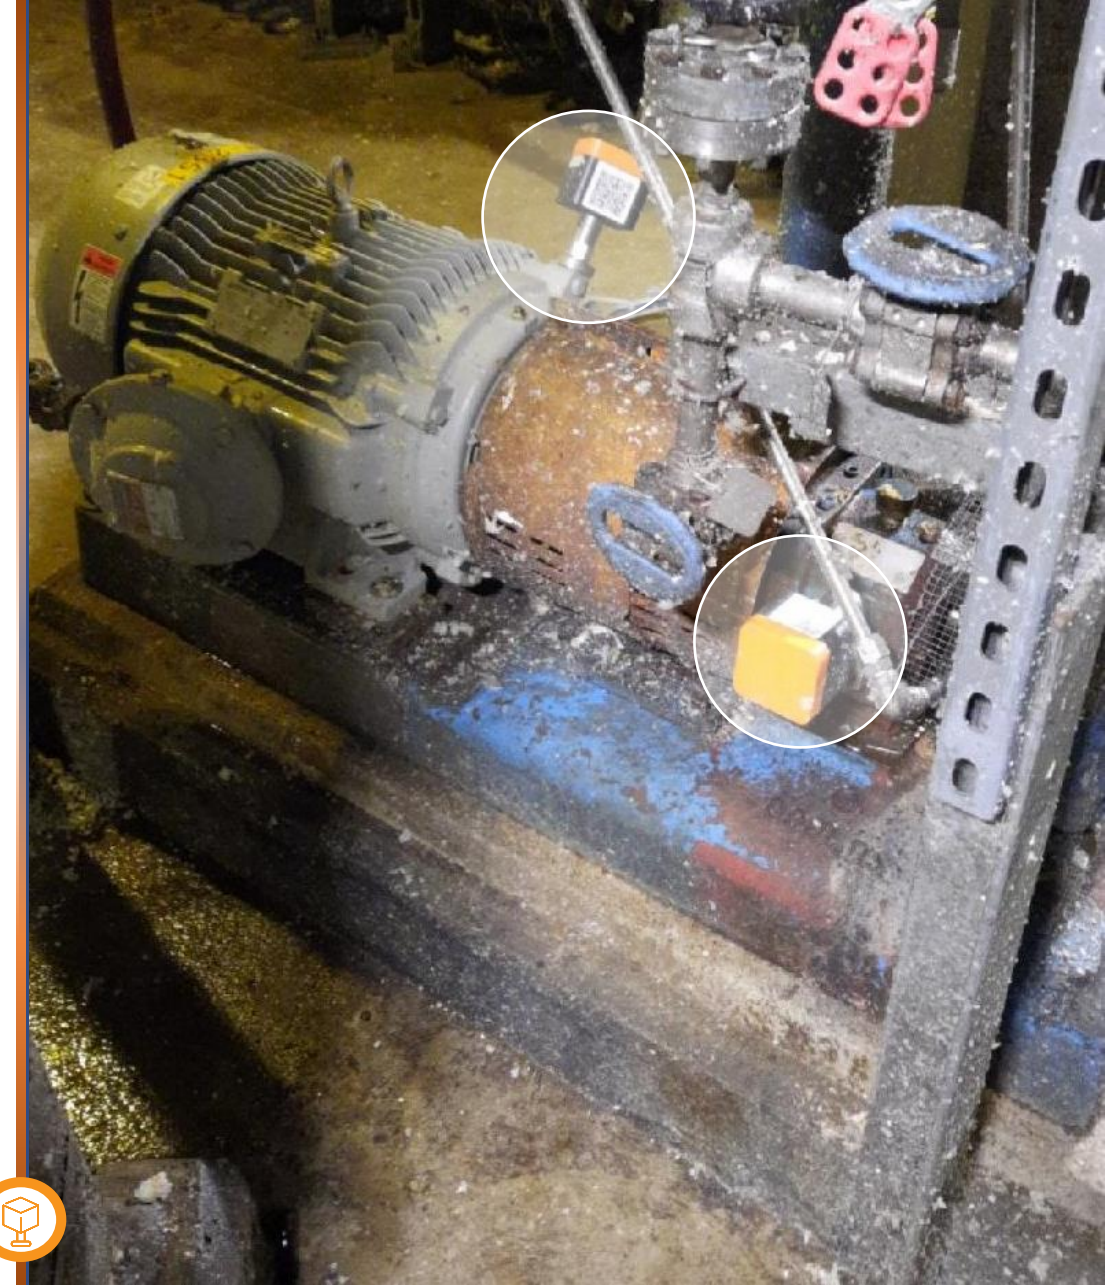
Detected Abnormality

- **Low amplitude sidebands** in the high frequency data at **3.09 orders**, which is very close to the **outer race bearing** defect frequency in the motor bearings.
- The waveform data was also showing just over **14 G's peak to peak**.

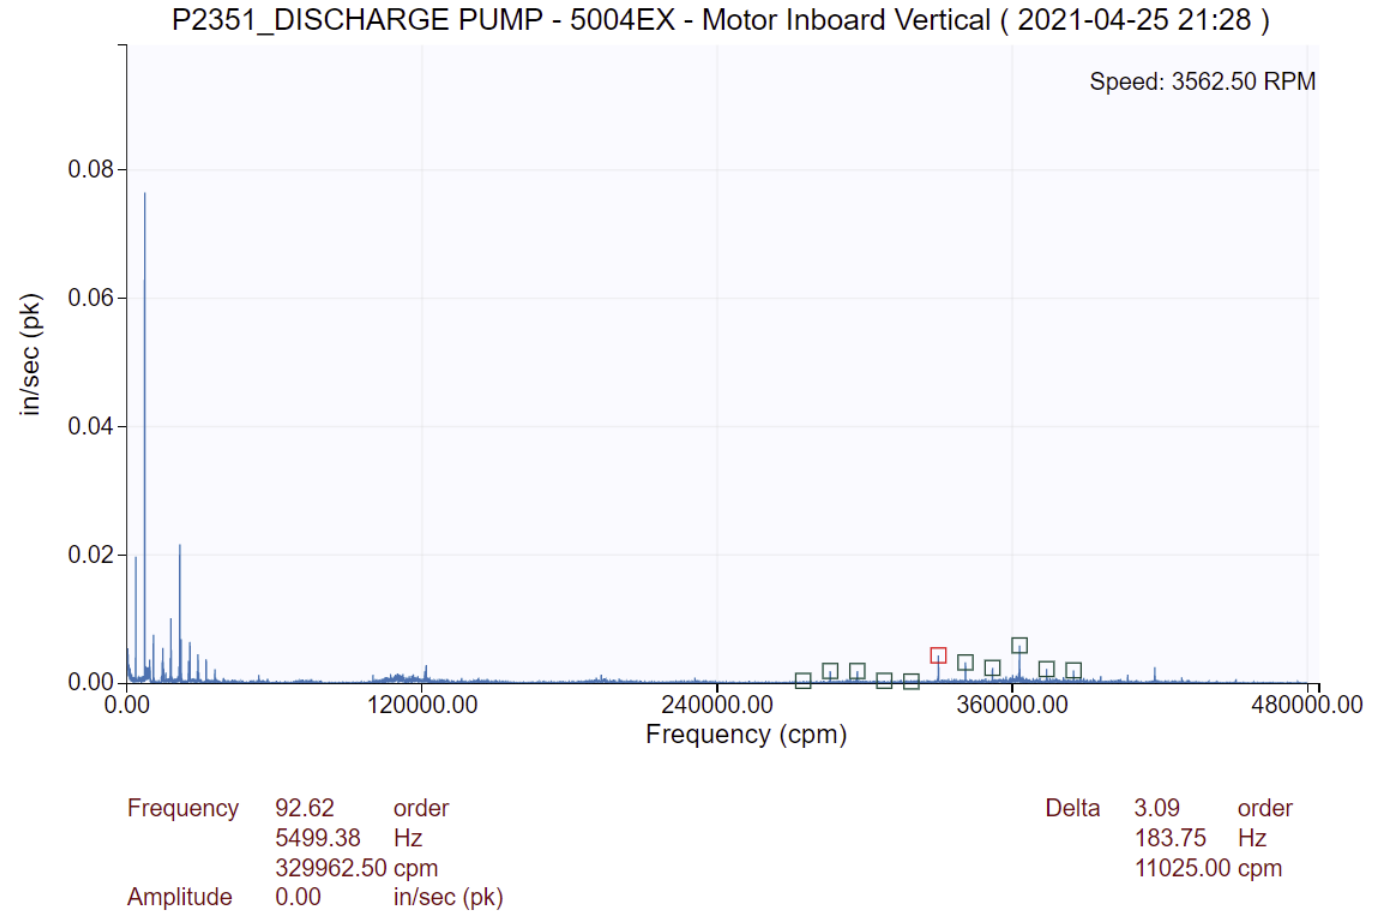
A closer look at the **acceleration spectrum** shows the sidebands of **outer race defect** frequency clearly.

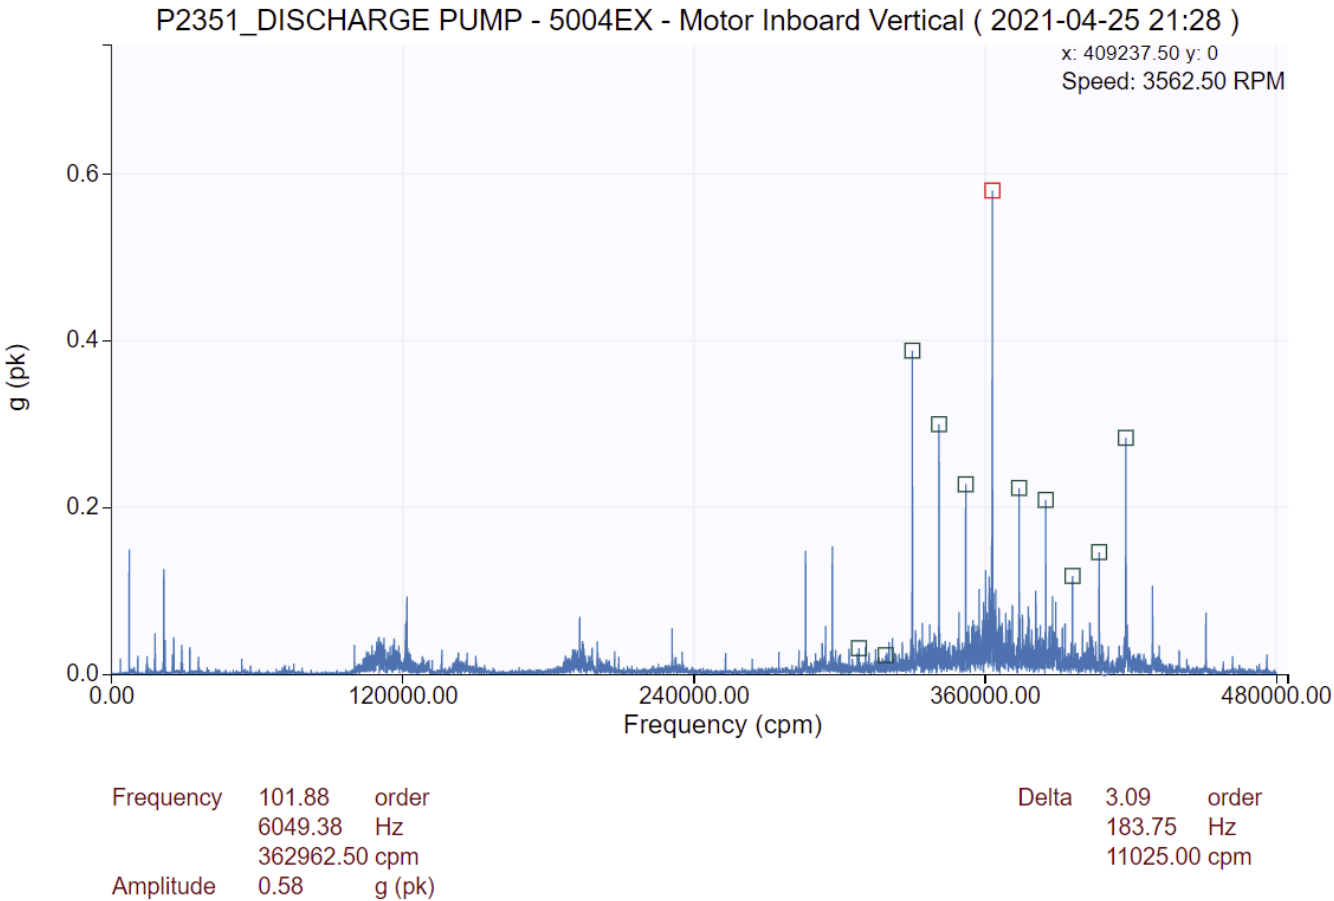
The **I-DNA** measurement (High frequency vibration analysis technique) also shows the **harmonics of 3.09 orders** confirming the **existence of an outer race bearing defect**.

- Based on our findings our recommendation was to **replace the motor** and **laser align the machine**.
- **Ensure the coupling** and all of its components are **in good condition**.
- Ensure that all **machine bolts** are **torqued properly**.

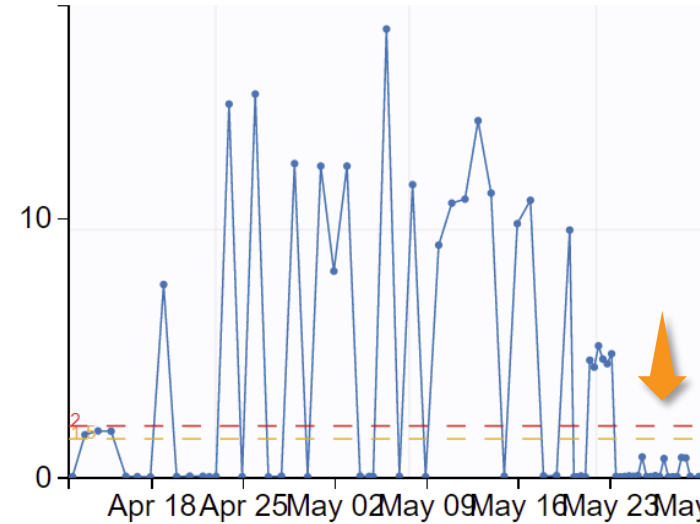
5004EX - Motor Inboard Vertical

- The motor was **replaced** on **5/25/2021**.
- The trends show a clear **improvement** of the **vibration values** on the motor.

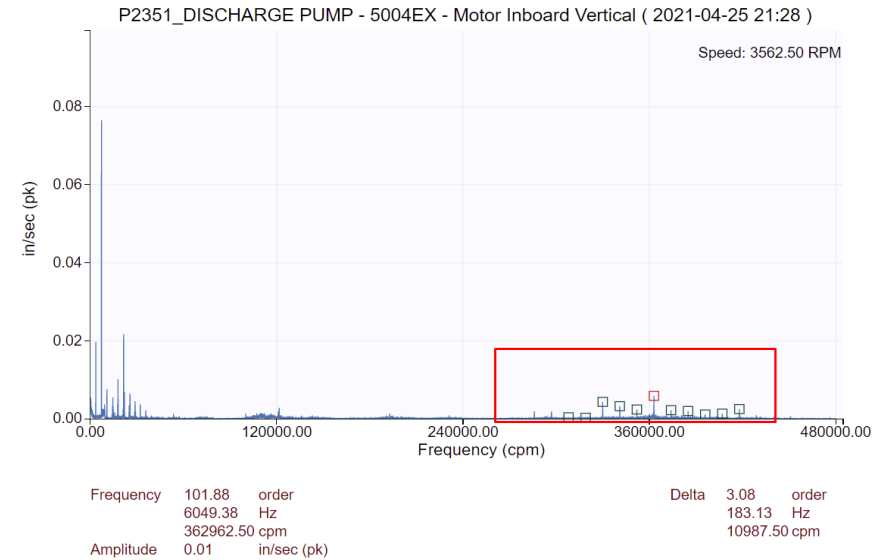
- 1 The data showing the defect.
- 2 After repair and lower scale showing no frequencies in the high range related to a bearing defect.
