Technical Case Study

Industry: Steel

Technology: Vibration and Oil Analysis

Machine: Conveyor System

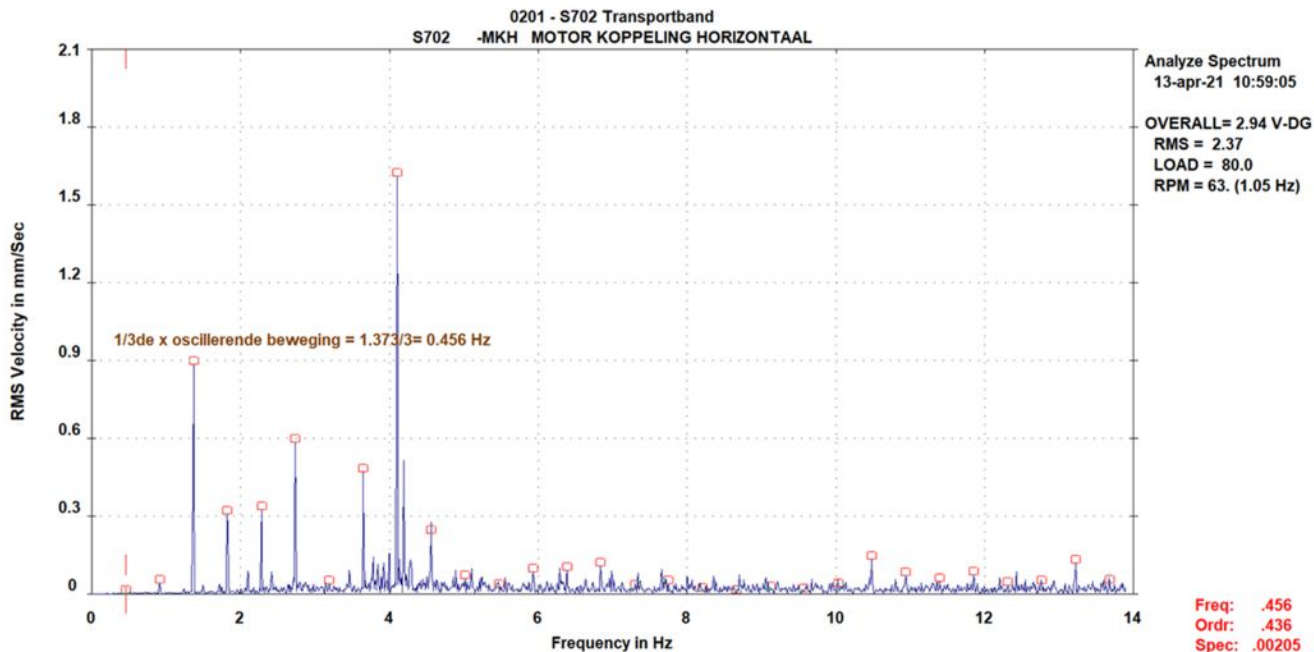
Thanks to all the data acquired on site, a more detailed analysis has been done and could reveal that the **vibration corresponds to 0.456Hz and multiples**, with the 3rd harmonic and multiples being the dominant component.

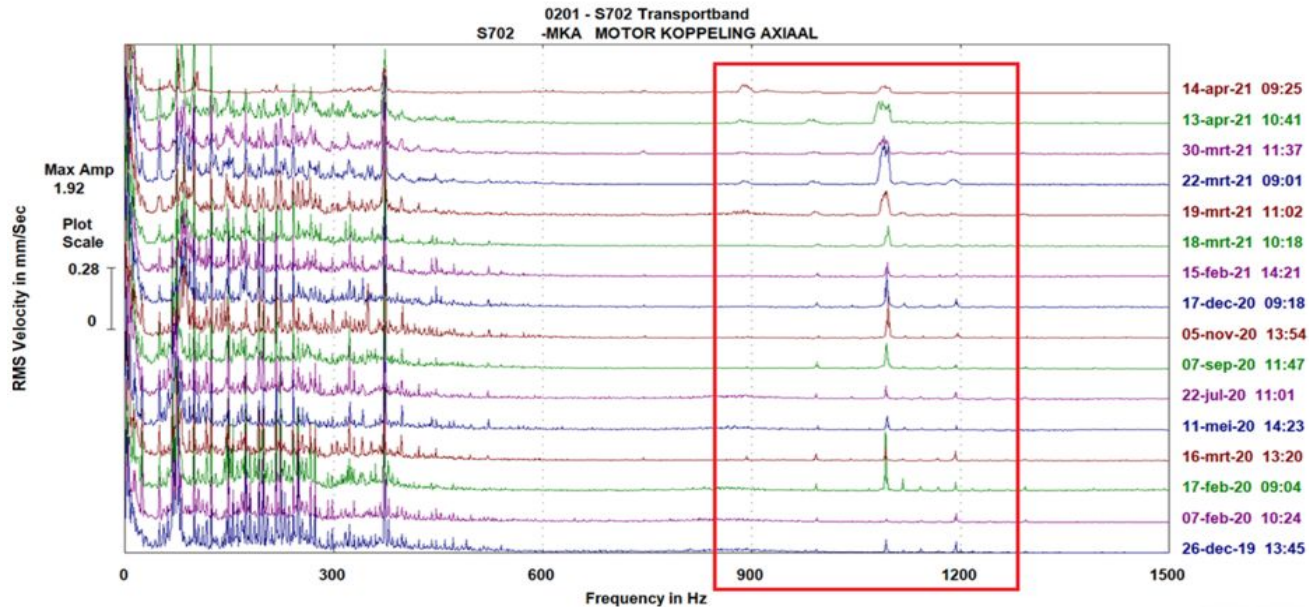
It is also observed that the electric frequencies in the high frequency part of the spectrum (slot pass frequencies) are smeared, since the oscillating movement of the drive is noticed, in March 2021.

This indicates an unstable speed and can explain the unstable motor current.
