Technical Case Study

Technology: Vibration Analysis

Machine: Belt Driven Fan

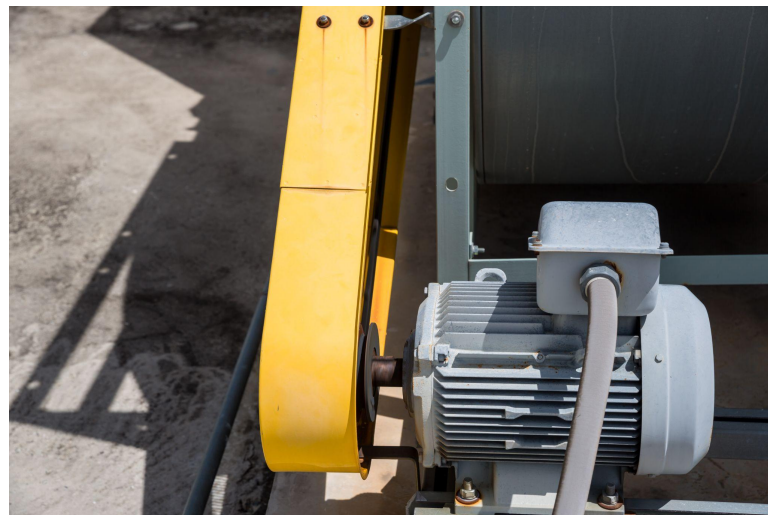
Some time after the inspection, an operator notices an **abnormal noise** and an additional measurement is taken on **motor and fan**. Once the motor is off, after 15 seconds, we can see some smoke coming out of it. On October 7, an uncoupled measurement is taken on the motor.

Machine	Belt driven fan
Latest deviated measurement	September 29, 2022
Baseline measurement	October 2022A
Running speed	2980 RPM (M) / 2500 RPM (F)

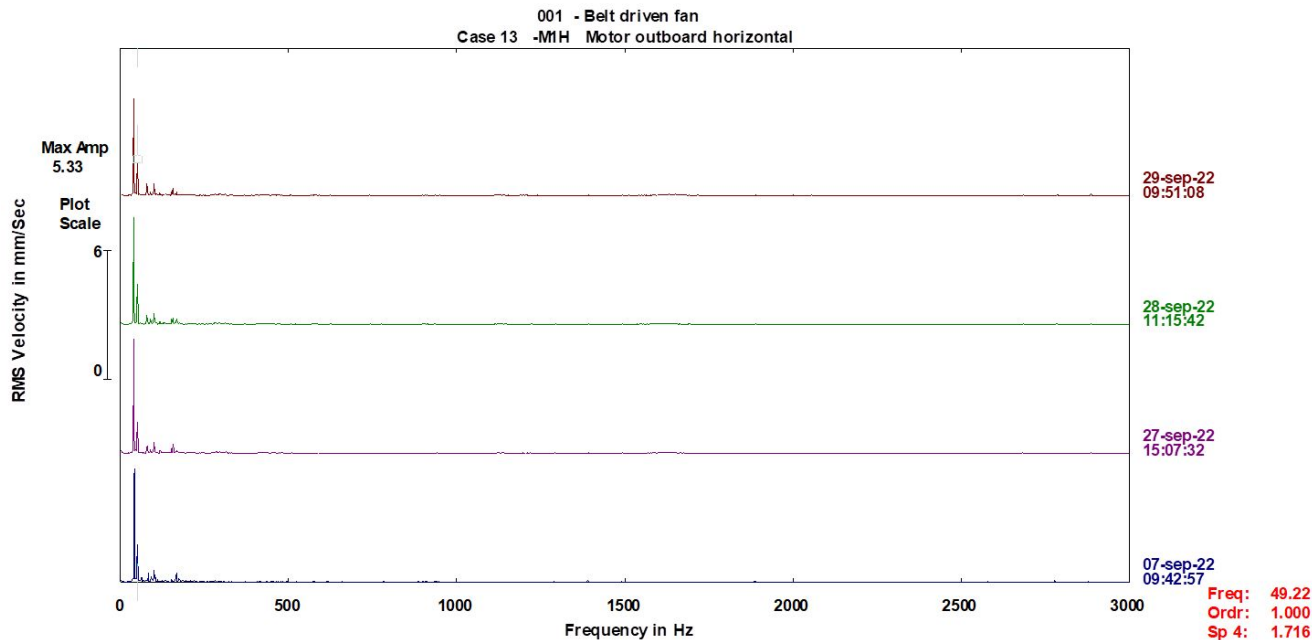
This data is showing a very **stable trend** when the data sets are viewed in a **velocity scale**.

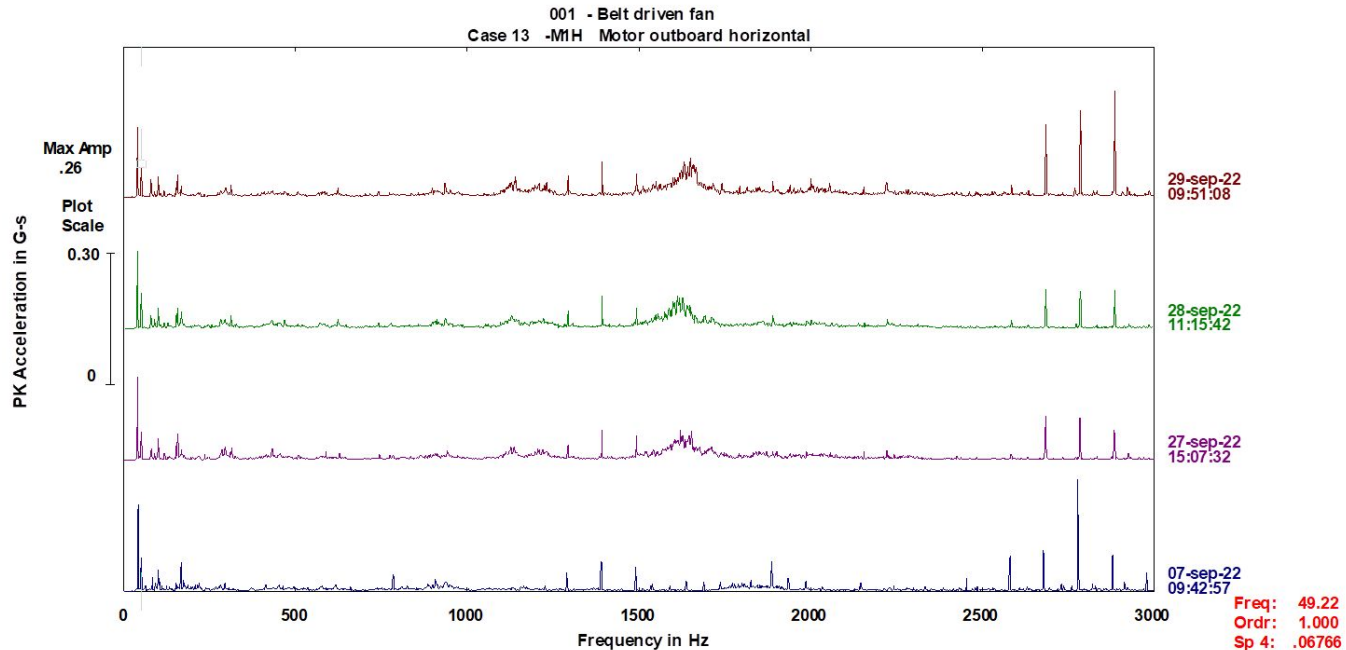
When viewed in an **acceleration scale**, we can notice a clear increase of the **noise level** around **1600 Hz**, which can explain the abnormal noise. However, the reason for this increase is not yet clear.

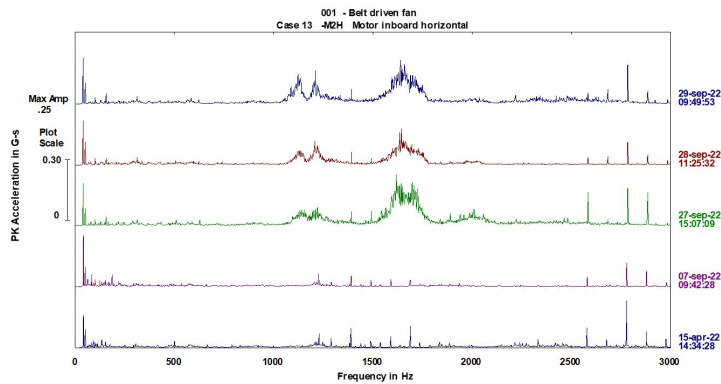
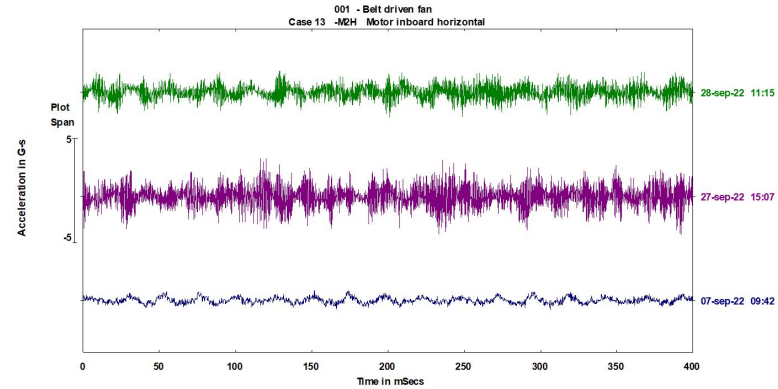
This **noise increase** is even clearer on the trend based on the vibrations generated on the motor (belt side), both in the **waveform and the spectrum**.

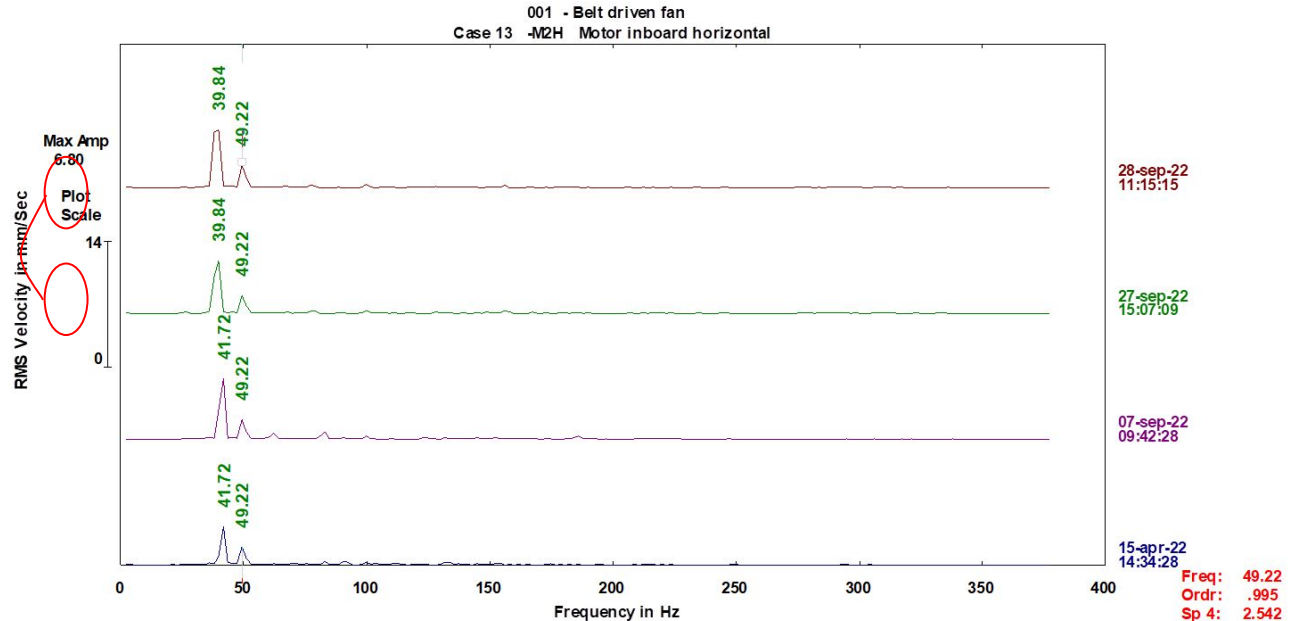
If we are looking in the details, we notice that the **fan speed is 1,86 Hz or 110 RPM**, which is lower than before the inspection, while the motor speed didn't change.

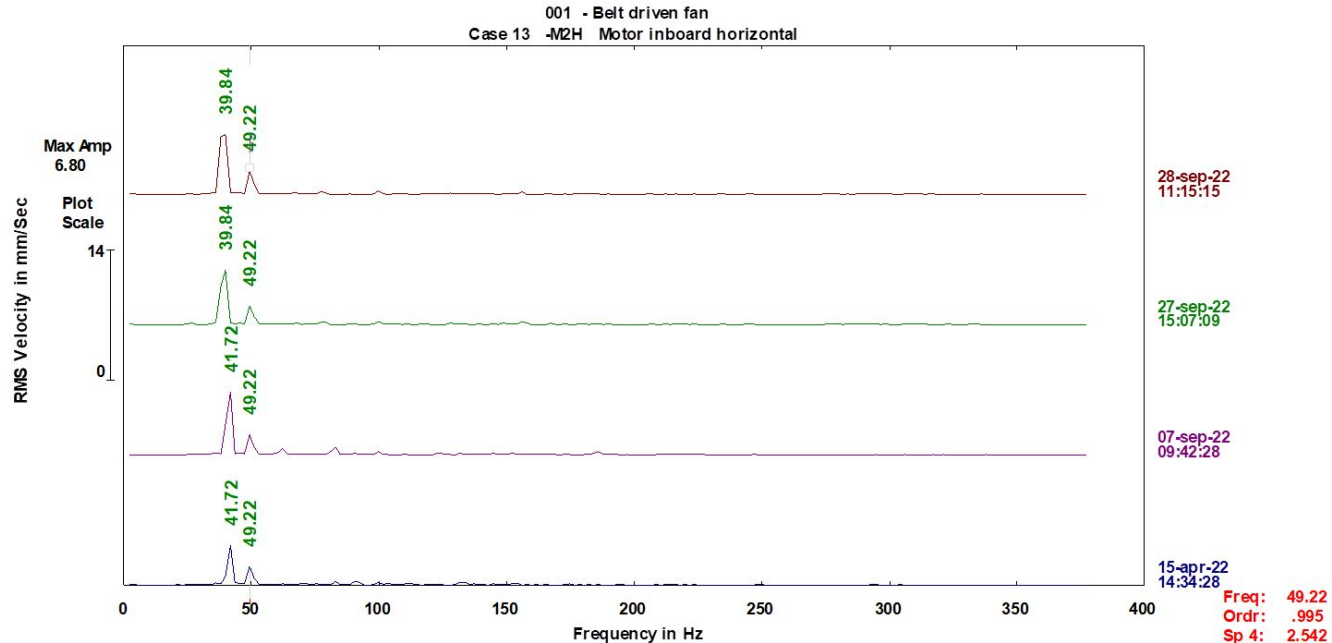
The lower speed can be explained by **excessive belt slip**, caused by low belt tension. This slip can also explain the noise in the spectrum as well as the abnormal noise heard by the inspector. It was recommended to check the **belt tension**.

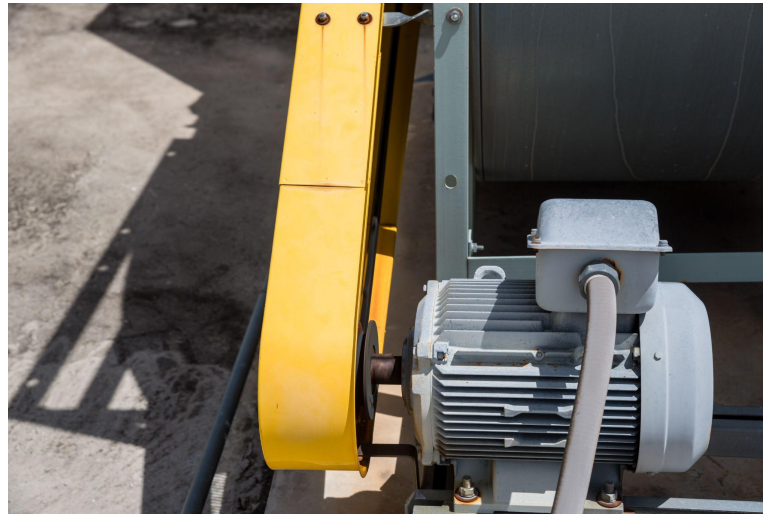
In **conclusion**, thanks to this follow-up and the measurements done before and after the inspection, we were able to detect a **defect on the belt coupling**.

It was confirmed that the **belt frequency (belt resonance) is 10Hz lower** compared to the required value.

Following these proposed actions, the belt tension was checked and modified and the **noise and the vibration disappeared**. The **correct belt tension will also decrease energy consumption up to 15%**.
