Technical Case Study

Industry: Tires

Technology: Vibration analysis

Machine: Fans

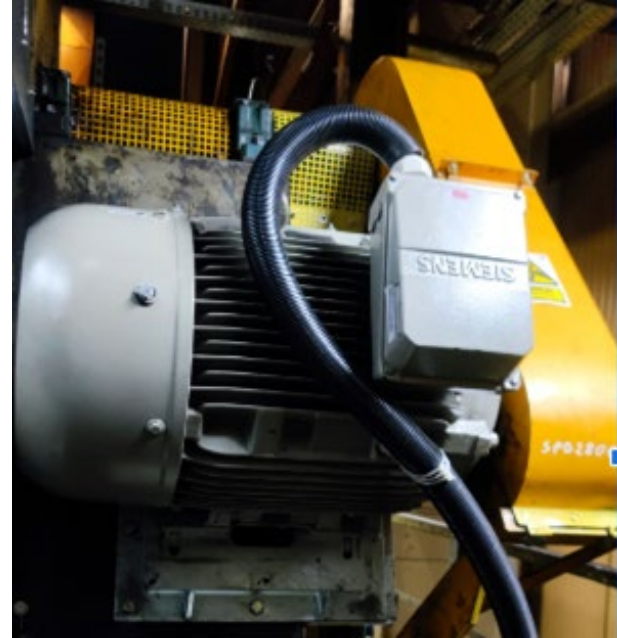
As part of periodic predictive measurements, I-care performs routine vibration measurements on the production line every 2 months. In the period between measurements, the customer asked us for an additional examination, because after the modernization work carried out on the production line, they observed **disturbing sounds. Increased vibrations on the fans visible to the naked eye were detected. These fans are critical in the tire plant** (one of them can be seen in the photo on the right).

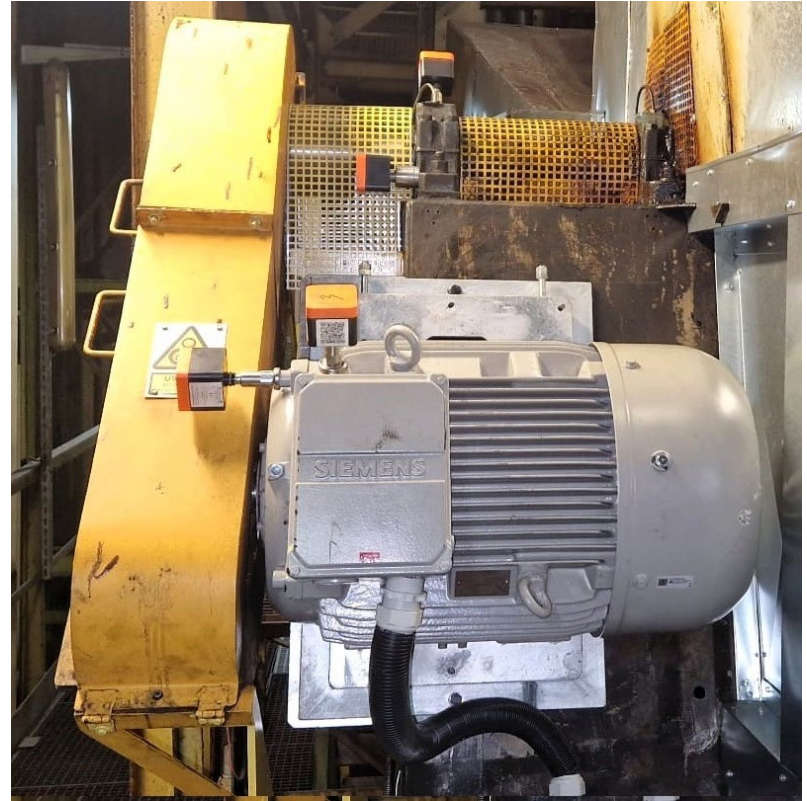
Based on their knowledge of vibration and machine construction, I-care specialists concluded that the increase in vibration was due to reduced stiffness and a change in engine attachment points.

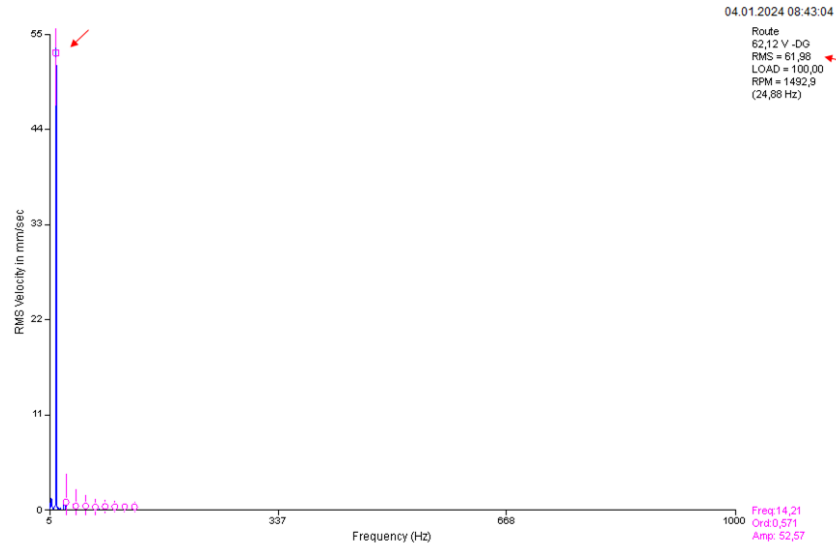
Vibration measurements taken for several days in a row showed that the amplitudes were increasing, which could result in a serious breakdown or accident. The highest level of vibration speed was recorded on the W2 Right fan at the BAV measuring point - 61.98 mm/sec RMS. Of which the highest amplitude came from the frequency of 1X the rotor speed.

AMS Suite: MHM - Fan Vibration Speed

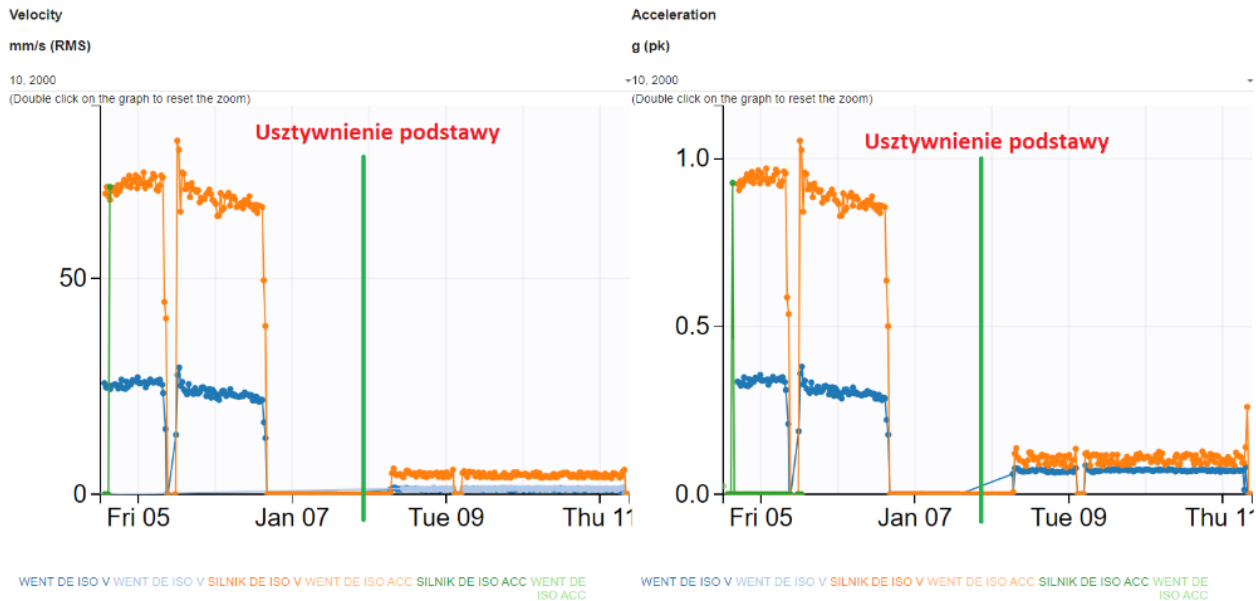
The following trend from the I-see application shows the effect of base stiffening on the RMS value of vibration velocity and acceleration.

I-See - trend of the RMS value of the W2P fan vibration speed and acceleration.

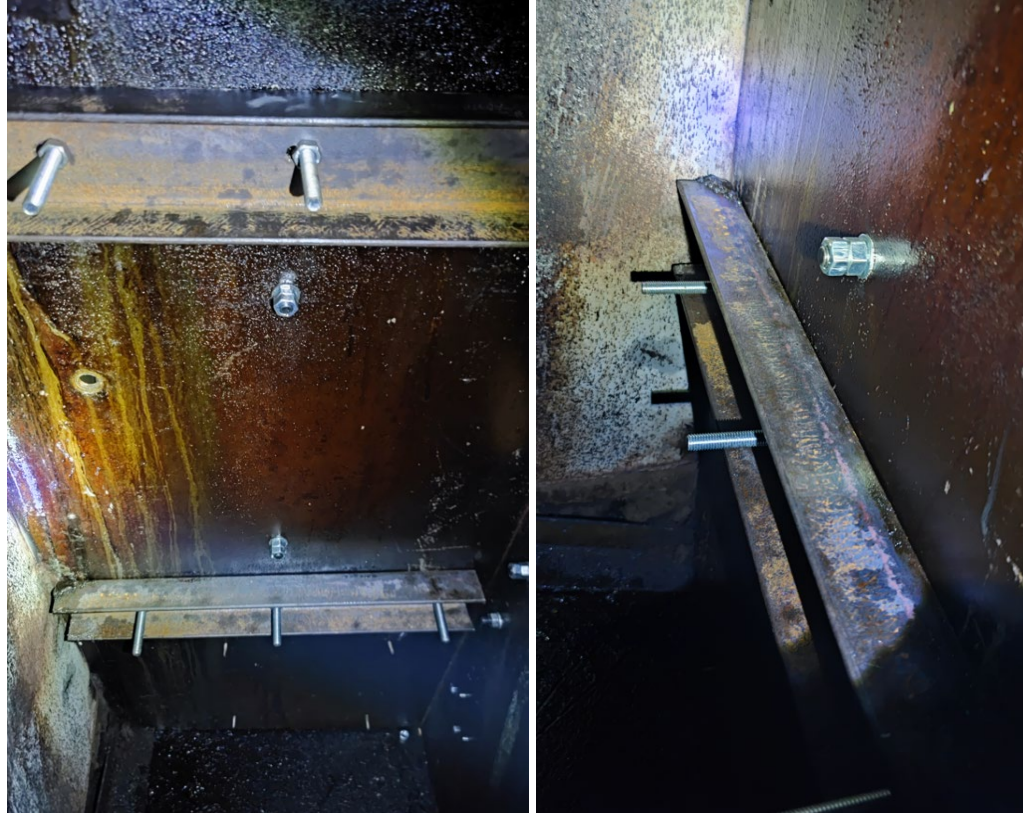
Strengthening the fan base according to the recommendations of I-care specialists.

After performing diagnostic tests, collecting data from the Wi-care™ system and analyzing the problem in depth, I-care engineers concluded that the solution would be to strengthen the base of the machine by mounting the channel sections.

The mechanics of the tire plant implemented the recommended repair work. After it was performed, we re-analyzed the vibration measurements made with the Wi-care™ system. After fixing the channel sections in the center of the base in the places of attachment of the motor, the effective value of the vibration speed

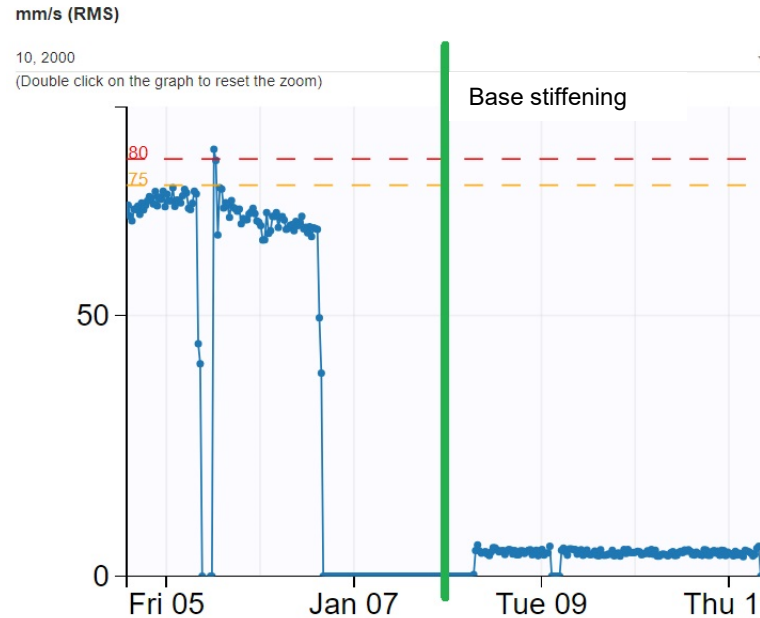
The Wi-care™ system recorded a vibration speed of 75.79 mm/sec RMS before the base was stiffened. When the base was stiffened, the vibration speed dropped to the level of 2.96 mm/s RMS.

Vibration velocity graph in mm/sec RMS of the Wi-care™ system from the i-See app.
