Case Study | Route-based Vibration Analysis

Machine Overview

- Cardboard
 - Max Speed 780 MPM
- Running Speed: 165 RPM
- Measurement periodicity: **3 weekly (offline) measurements**
- **Problem:** Bearing damages on drying cylinders

Cylinder 26 - Measurement of the Drive Side Bearing

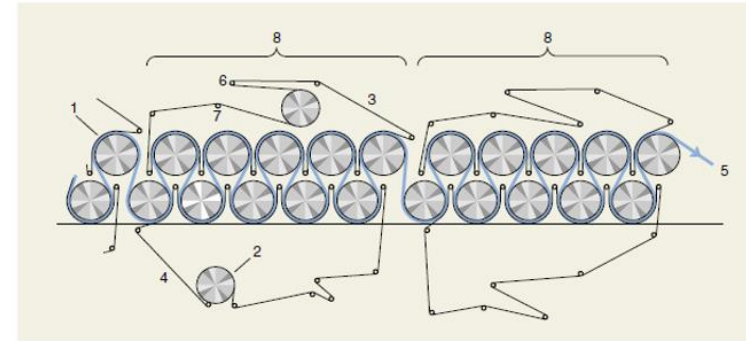
- Traditional drying section
1. Drying cylinder
 2. Felt drying cylinder
 3. Top felt
 4. Bottom felt
 5. Paper web
 6. Felt stretch roll
 7. Felt guide roll
 8. Drive group

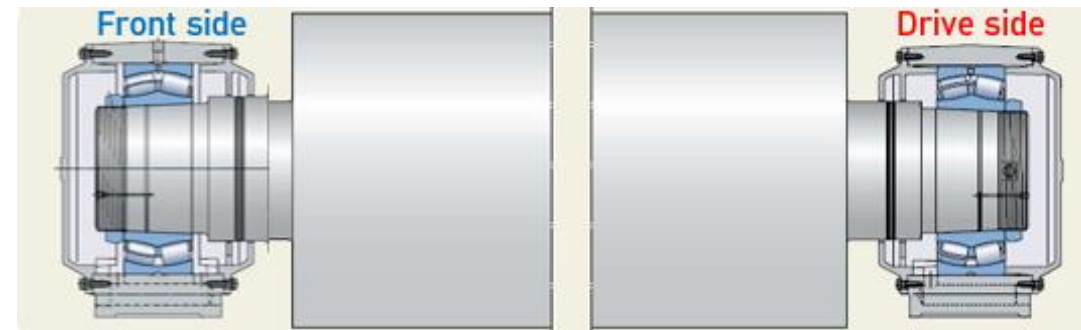
Non-located outer ring
for thermal expansion

Located outer ring
in the housing

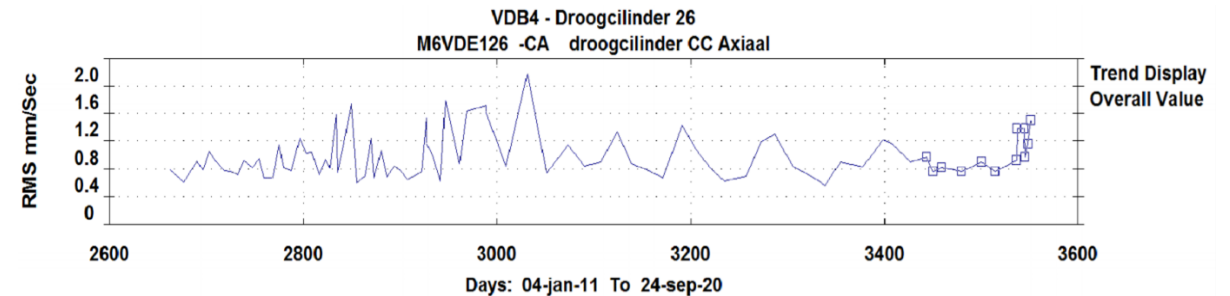
Cylinder 26 – Diagnosis for the Drive Side Bearing

- To find the origin of asynchronous frequency at 13,2x order, the bearing fault frequencies are calculated manually by decreasing the number of rolling elements.
- BPFI of a 23044 CCK bearing with 24 rolling elements is calculated as 13,25x order.
- So, early bearing damage was apparently present on the drive side of the drying cylinder-26 (given the lower amplitude levels compared to the bearing damage on the front side bearing).

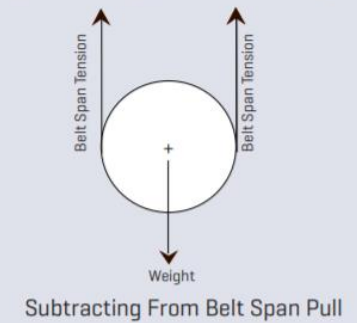
Bearing Load

Bearing load is another commonly used term. Weight and tension applied to the shaft exerts a force on the supporting bearings. The amount of this force depends on where the bearings are located on the shaft in relation to the center of the sheave or sprocket, where the pulling force is being applied.

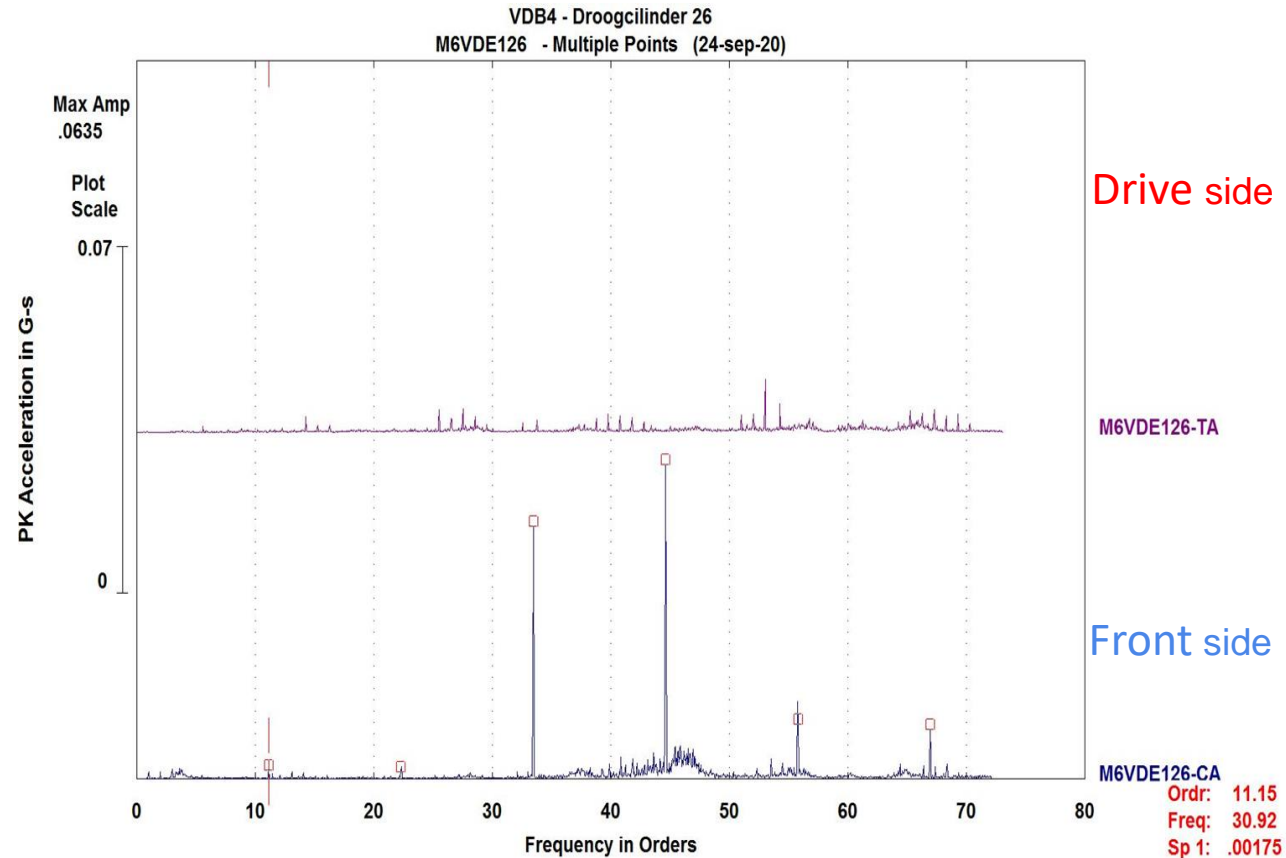
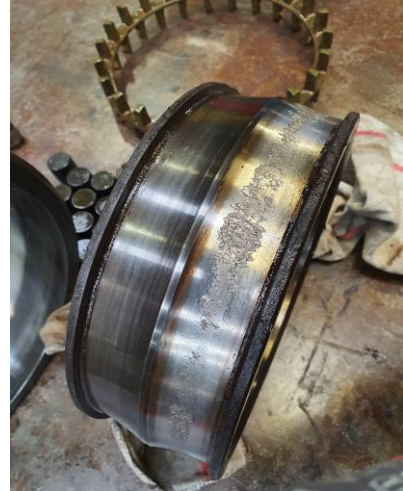
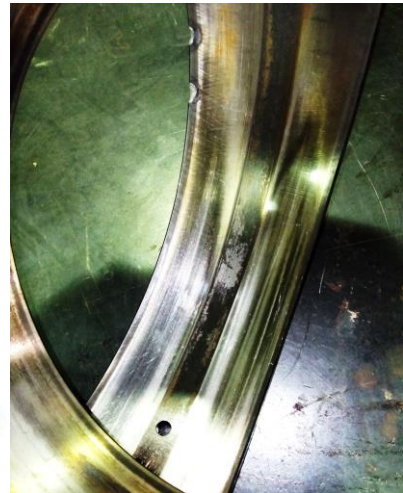
Cylinder 26 – Measurements compared to Damage Pictures

1. Severity determination of bearing damage cannot be done solely based on amplitude levels.
2. Look for evolving patterns in spectra & time signals, elevating noise floors, changing trends,...
3. Noise measurements are sometimes very useful to identify the bearing problems: use a stethoscope.

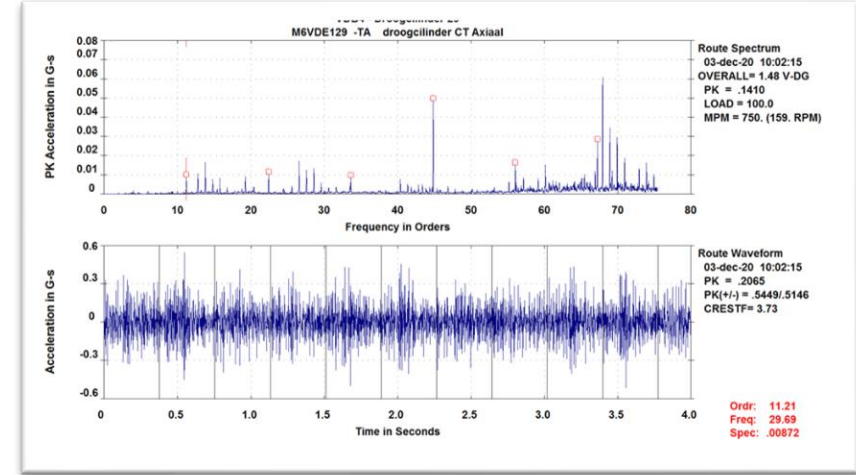
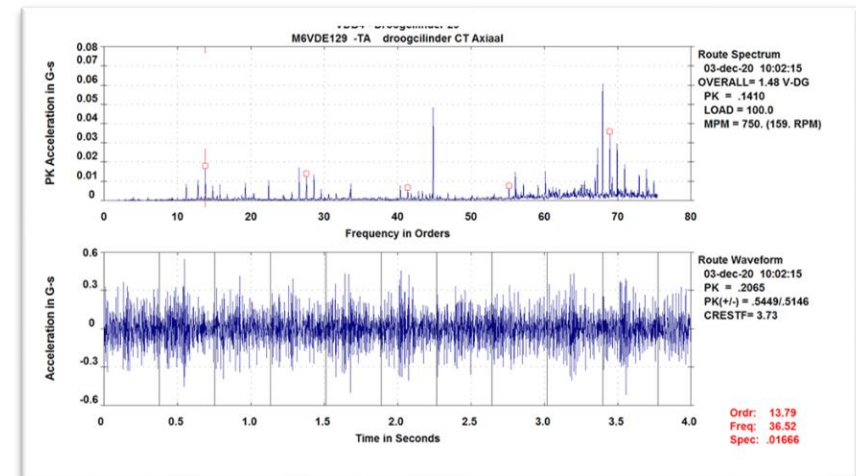
Cylinder 29 - Exact Location of the Bearing Damage. Front Side vs. Drive Side, cont.

1x order and harmonics:

Likely some looseness or an indication of severe bearing damage (because bearing fault frequencies are also present)?

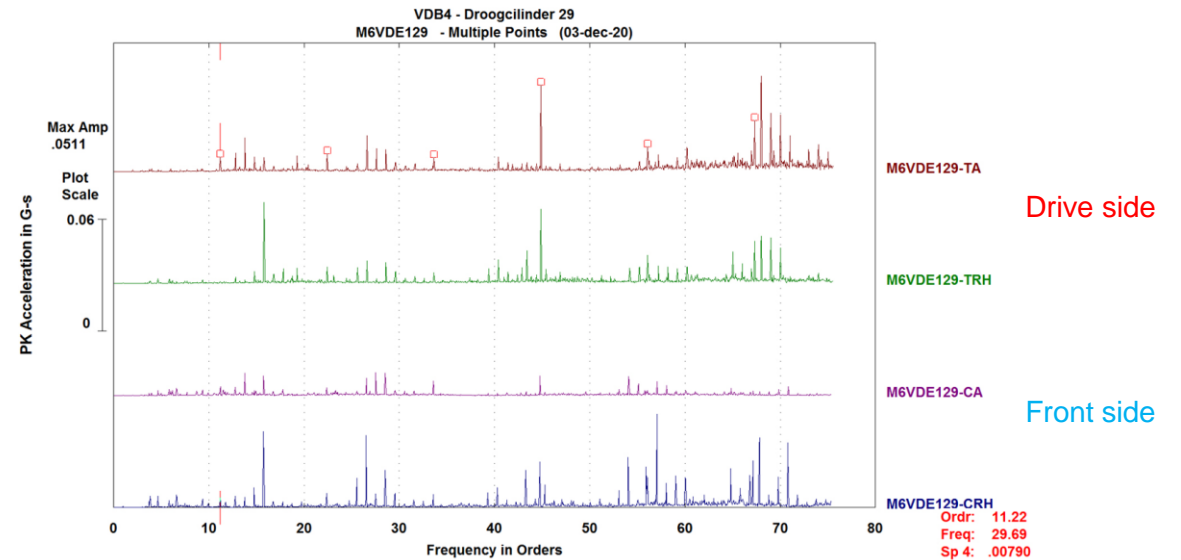
Given more sidebands at 1x, BRFI (13,8x) on the front side?

Or given higher amplitude levels, BRF0 (11,2x) on the drive side?
