Case Study | Wireless Monitoring System

Machine Overview

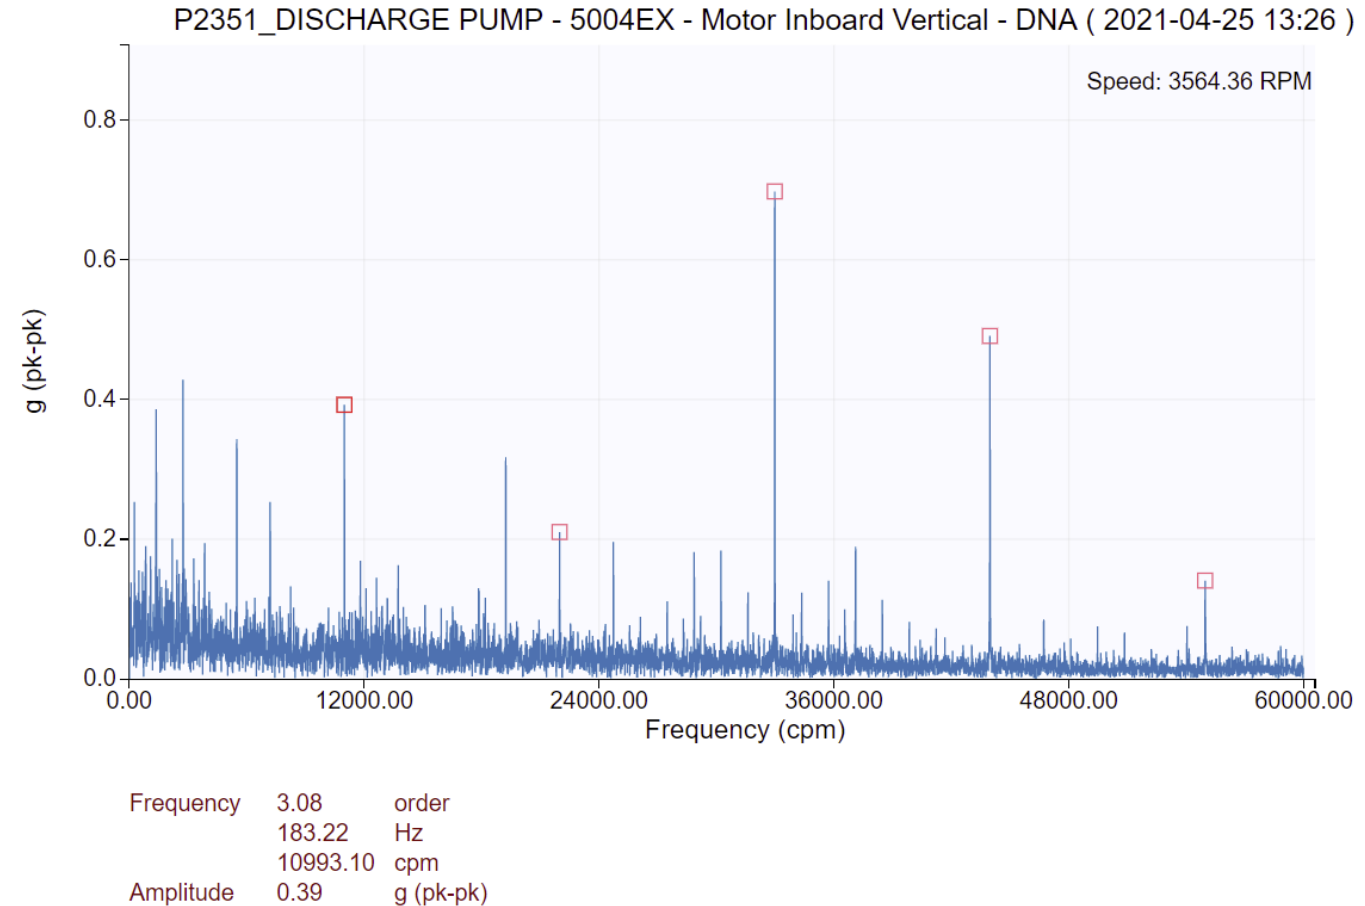
The **I-DNA** measurement (High frequency vibration analysis technique) also shows the **harmonics of 3.09 orders** confirming the **existence of an outer race bearing defect**.

- Based on our findings our recommendation was to **replace the motor** and **laser align the machine**.
- **Ensure the coupling** and all of its components are **in good condition**.
- Ensure that all **machine bolts** are **torqued properly**.

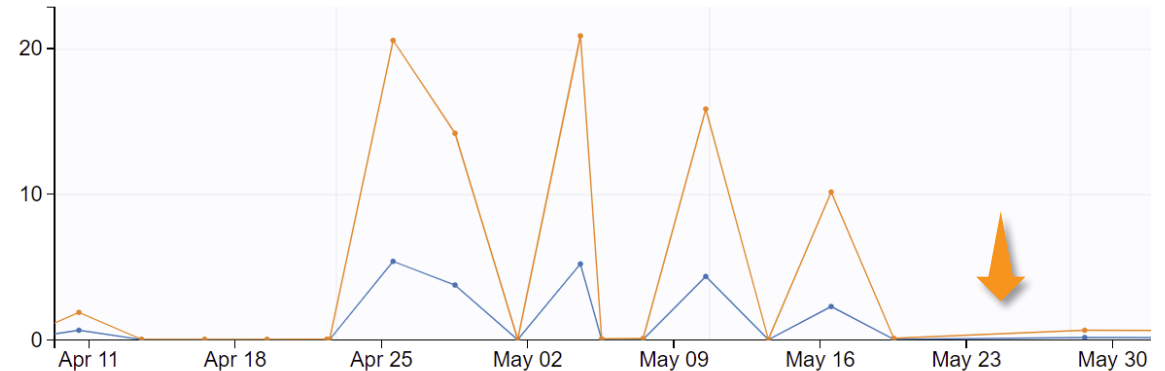
5004EX - Motor Inboard Vertical

- The motor was **replaced** on **5/25/2021**.
- The trends show a clear **improvement** of the **vibration values** on the motor.
